CASE STUDY ON ELECTRICAL LEAK LOCATION USING BOTH WATER PUDDLE AND DIPOLE METHODS ON A MINING WASTE CAP TOTALLING 255,000 M²

C. Charpentier, A. Ait Mekourta, T. Jacquelin, and H. Bremner, Groupe Alphard, Montreal, Canada

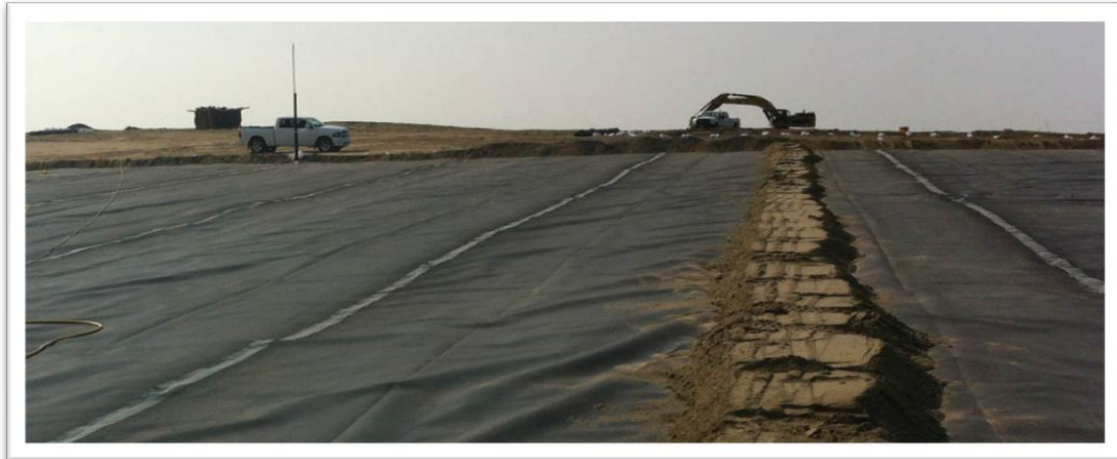
The ELL company's first realization upon arriving on-site was that strips of sand (roughly 1 m wide and 30 cm high, shown in Figure 3) had been deposited directly on the geomembrane, along the full length of a roll, at the end of each day (roughly 6 widths of geomembrane). As this was a mining waste cap, the subgrade was raised, and therefore more exposed to wind. Sand bags had not been sufficient to keep the structure safely in place, the longest slopes being roughly 90 meters long. It was therefore decided that a width of sand would be placed on the geomembrane at the end of each day of installation. As such, those sections could not be surveyed using the water puddle method, and were only surveyed using the dipole method.

Figure 3. Ballast sand strips on the geomembrane

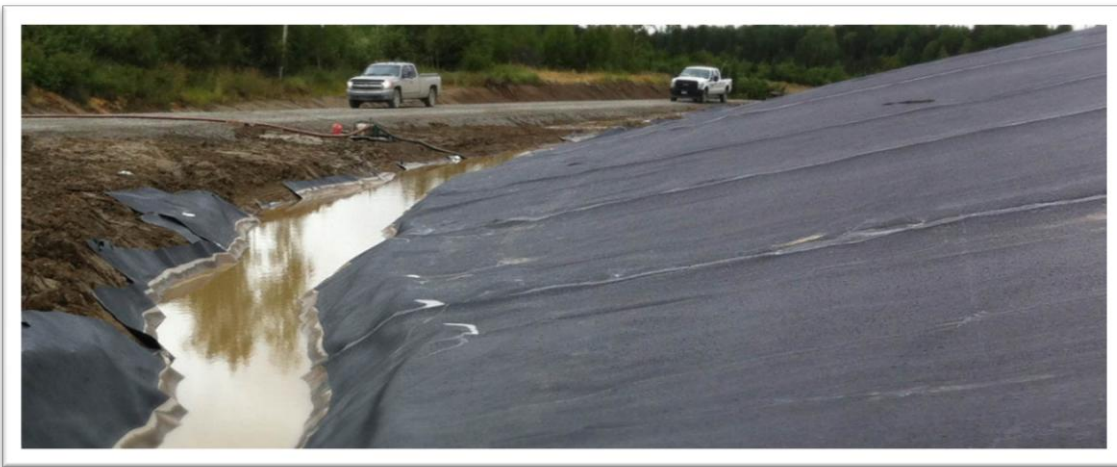
The capping is designed to be drained by a trench that runs along its periphery and gently slopes to a low point. During the water puddle survey, the site received consistent rainfall that filled the trench, sometimes above the height of the geomembrane (see Figure 4). This electrical contact between the water within the trench and the soil outside cancelled the electrical isolation, giving a constant false positive signal (the water collected from the huge slope flowed down into the trench, which was in contact with the exterior). The water level in the trench therefore had to be brought down below

Figure 4. Loss of electrical isolation in the trench

the level of the geomembrane. The subsequent trenches were covered by geomembrane up to the top, to avoid this for the rest of the mandate.
