CASE STUDY ON QUALITY CONTROL AND LEAK LOCATION PERFORMED ON A BITUMINOUS LINER MINE CLOSURE PROJECT NEAR THE ARCTIC CIRCLE IN NWT, CANADA

H. Bremner, J-F Bélanger, C. Charpentier, and T. Jacquelin, Groupe Alphard, Montreal, Canada

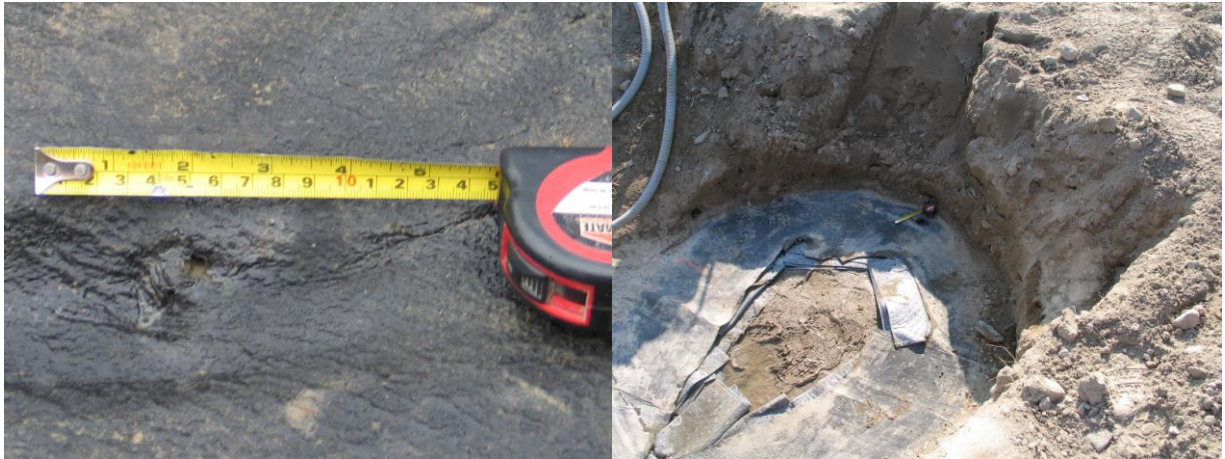
Finally, three test pads were constructed with different configurations. On the first test pad, measuring approximately 1,800 m², a total of 7 leaks were found, with a cover material thickness between 700 mm and 1,020 mm. All leaks were punctured through and ranged in size from 5 mm to 150 mm (see Figures 2 and 3). Upon further inspection it was noted that the subgrade surface on which the BGM was placed was not suitable, and that the cover material was not properly screened (rocks too large and too sharp, as shown in Figure 4). Boulders were found in the subgrade and cover material ranging up to 800 mm.

Figures 2 and 3. Various sized tears in the BGM (small tear, large tear)

needed for the bituminous geomembrane. Protective geotextile was added to the design: one below the BGM to protect it from the subgrade and one above to protect it from the cover material.

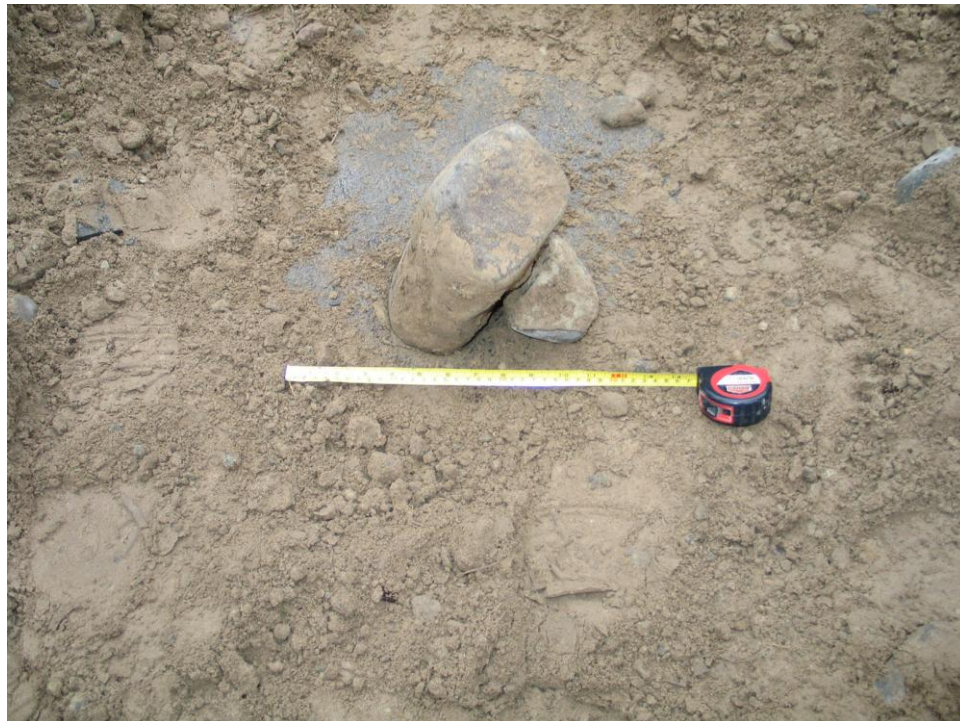
Figure 4. Out-of-spec-sized rocks found in the cover material

As no leak location survey was performed on the material prior to it being covered, it is cannot be said if any of those leaks were present prior to the installation of the cover material (even without it being subject to loading). The outcome was that both the subgrade and the cover material needed to be better screened, and some additional protection was

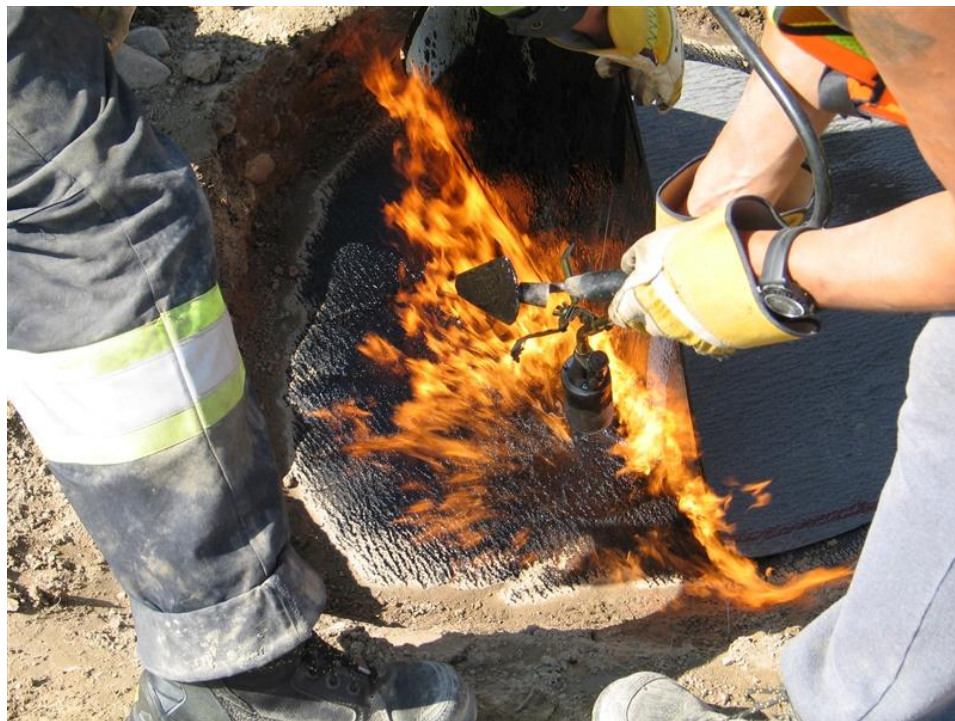
The site parameters and the type of material used had an interesting effect when performing the repairs. Firstly, when a leak was detected using the dipole method, the cover material had to be excavated to find the extent of the defect. With other types of geosynthetics, only a small work area needs to be cleared around the defect to perform the repair, therefore a similar sized area was excavated for the BGM repairs. With BGM however, repairs are performed by heating and melting the bottom of the patch with a torch onto the area needing to be repaired and then ensuring that the entire periphery is well sealed. Given the small work area cleared, as well as the “tunnel” from being surrounded by 700 mm to 1,020 mm of cover material, the flames from the torch enveloped the small work area (see Figure 5). A larger area was therefore necessary for repairing the BGM defects.

Figure 5. Repair being performed with workers near torch flames

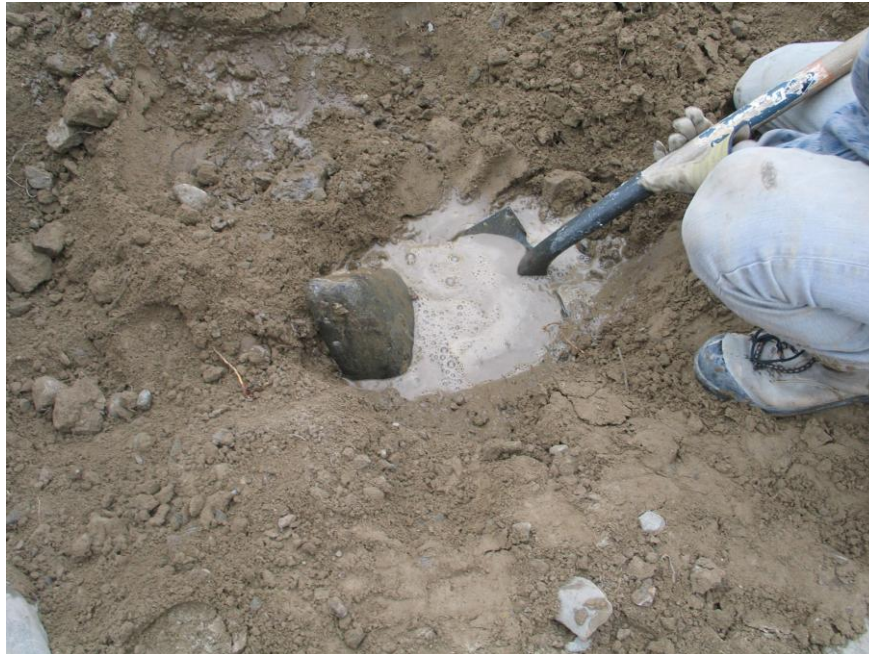
The other interesting effect, which was caused by the arctic location of the site, was the permafrost impact on the geosynthetic work. Since the BGM was black, it was heating up under the sun, and melting the permafrost in the ground. With the cover layer installed, a pressure was applied on the water trapped under the BGM. The impact was seen when the cover material was removed to unearth a hole and all of the pressure was applied to the area excavated; the BGM mounded with the water underneath, and when opened, a fountain effect was created through the leak. It was a

challenge to repair those defects considering the amount of water compressed under the membrane that was constantly flowing through said repairs (see Figure 6).

Figure 6. Rock being removed and water coming from beneath subgrade
