## Dipole Leak Location Survey on woodchip: unusual but possible.

### ABSTRACT

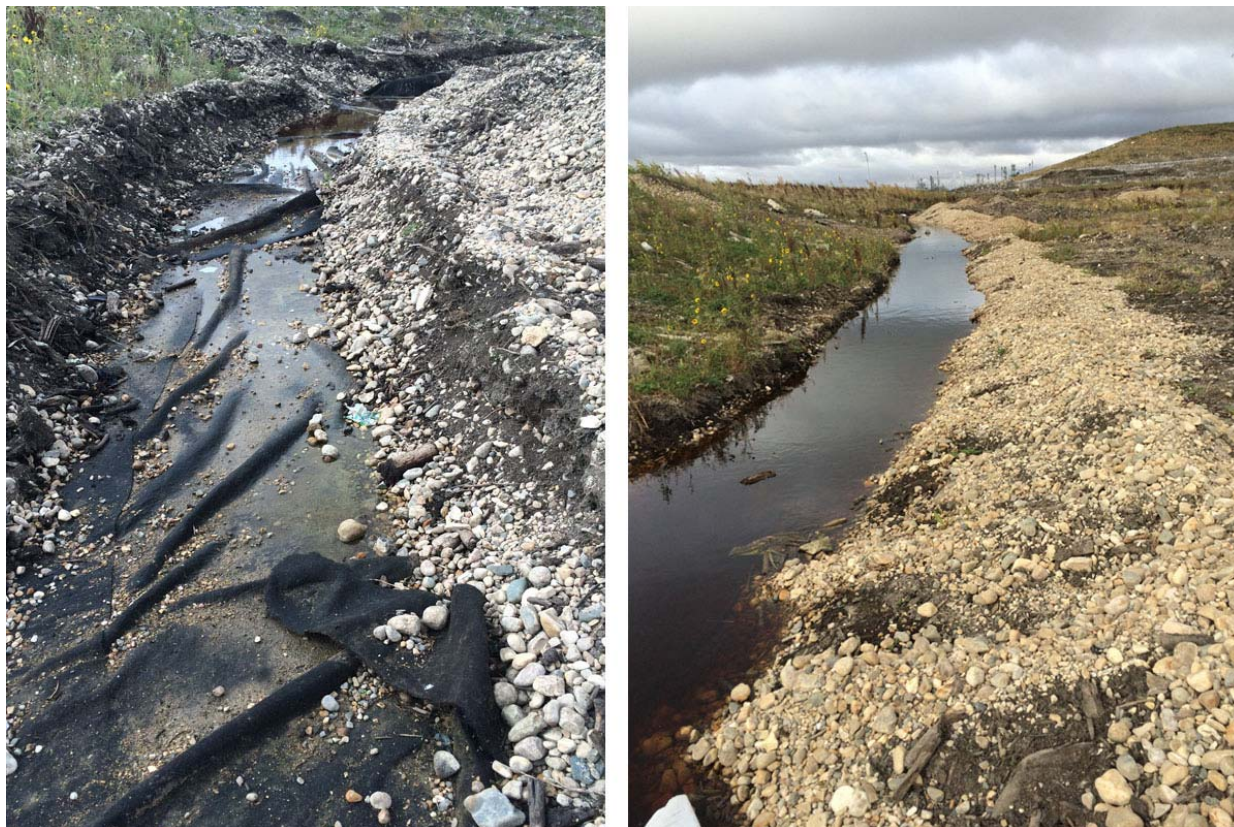
Upon arrival on-site, the first thing that got our attention was the location of the isolation trench. As seen on the dipole schematic on previous page, the best way to make such a trench is on top of the slope, for easy access, and also to keep as much surface as possible inside the boundary of the isolation trench. In this case, they decided to

build it at the toe of the slope. This decision resulted in numerous geomembrane tears, slopes with really poor isolation and poor leak location precision, highly risks for stability, and other problems that will be described in the next section.

Figure 2. Electrical isolation trench at the bottom of external slope

As for site conditions, it is easier and cheaper to plan leak location ahead of field construction, so isolation is dealt with during the placement of the covering material, and minimal excavation is required for access ramps and such. The result is better, and the risks and the costs are lower. It is crucial that all parties involved understand how leak location works and why, so when certain requests are made, we do not end up with isolation trenches at the bottom of slopes that automatically exclude all slopes from the survey.

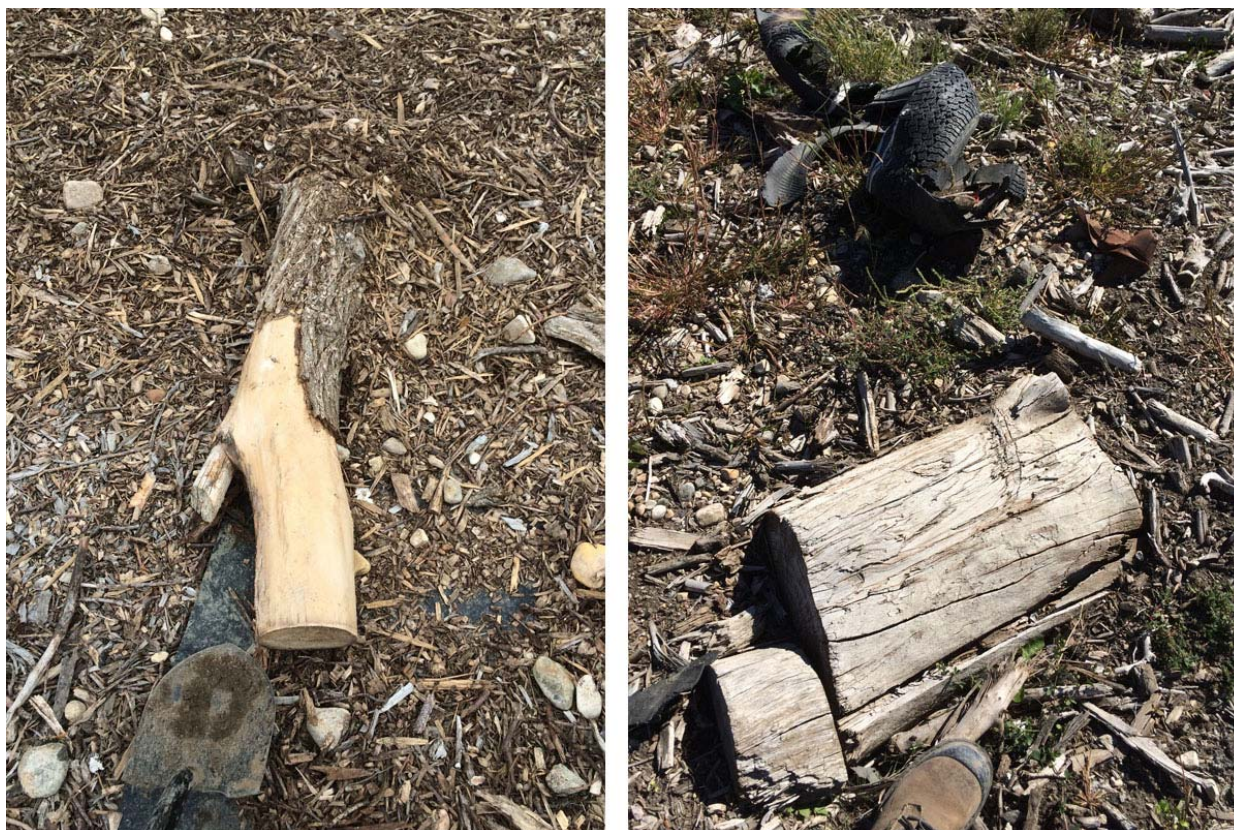
The second thing that was easily noticeable was the heterogeneity of the covering material. What was called gravel was in fact a mix of gravel, crushed stones, and dirt. The thickness varied greatly, going up to one meter, and sometimes the covering did not have any rocks, just sand and woodchips. The frost protection layer was also variable, and some pieces of wood were actually logs, with potential risks for the geomembrane's integrity. Many objects were seen in the gravel layer, such as broken glass, boots, and even a phone.

Figure 3. Woodchip containing big particles (logs)

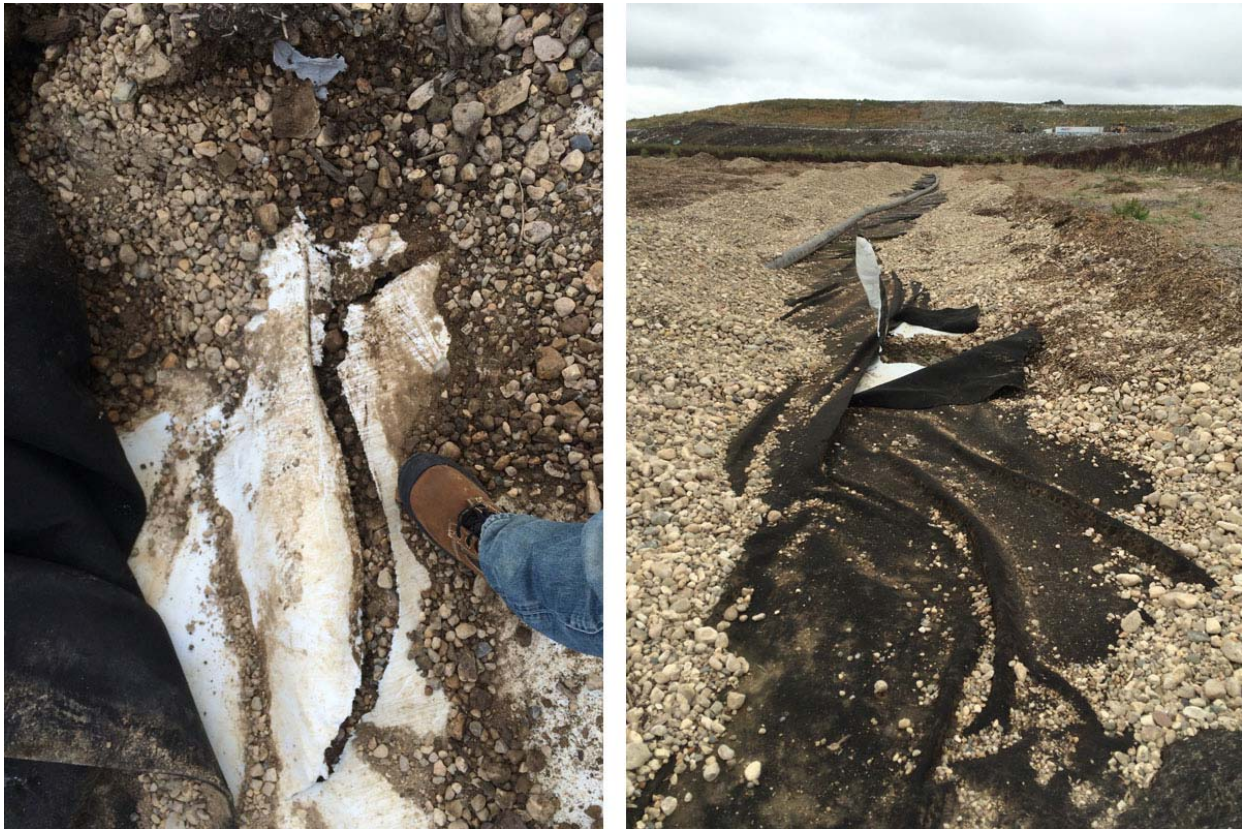
There is no doubt that the excavation of the trench was challenging, being at the toe of slopes. Walking the trench all around the cell, multiple tears and punctures were found. A total of 25 leaks of different sizes were marked with paint, and their location was recorded using a GPS. The amount of damage done during the excavation of the isolation trench gives a bad first impression on the global quality of the cell. Beside the extra cost to repair all those, these defects pose a great threat to achieving electrical isolation, because any dirt touching a hole will draw current and will diminish the signal of other surrounding holes. The whole trench had to be checked, and all defects were carefully excavated for two reasons: the electrical isolation, but also to make some room for the installer to repair the defects when returns to site.

Figure 4. Geomembrane damage example caused during excavation

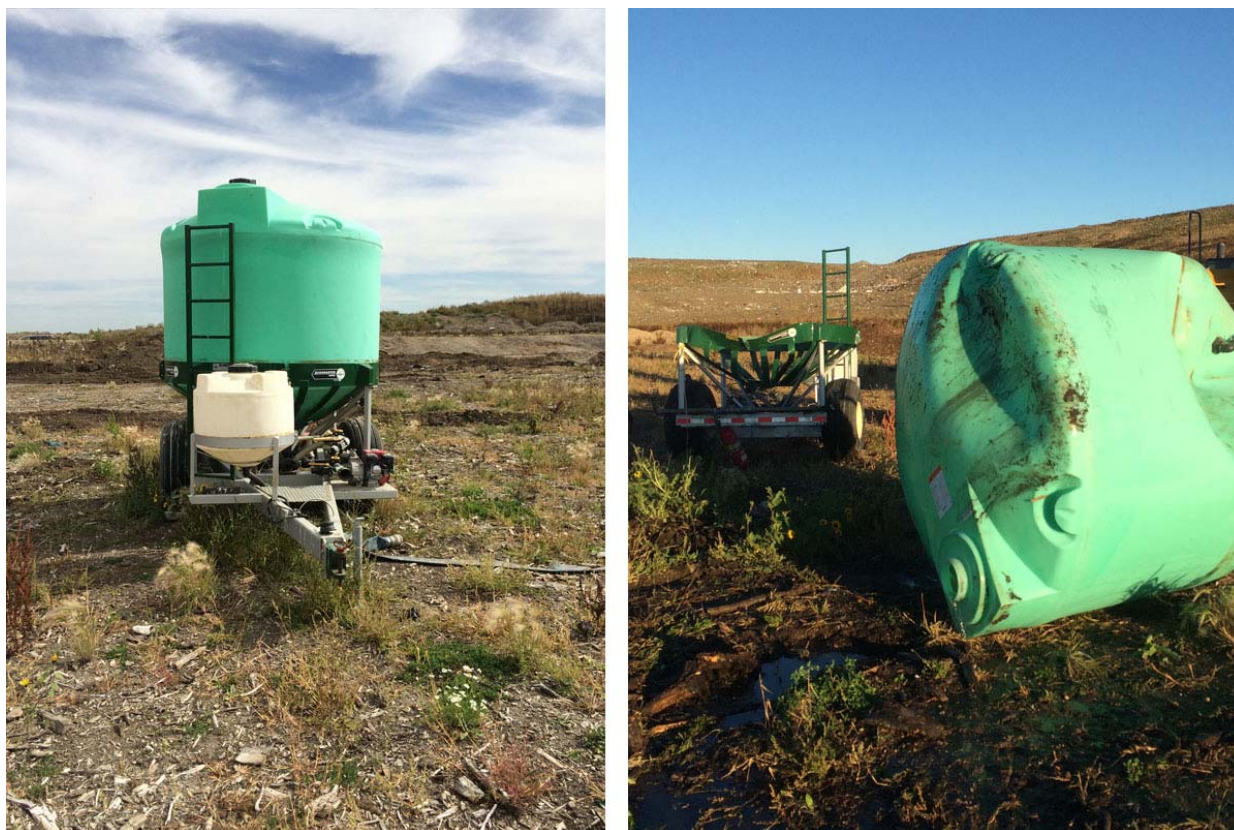
We knew a lot of surface watering would be required to get electrical signal through the wood layer. In fact, it was part of the first communication we had: uncertainty about the kind of results, if any, we would get surveying on wood. The plan was to soak the whole cell, and lots of water was required. Turned out we did not have the same opinion on “what is a lot of water”.

*Figure 5. Water reservoir problems*

The woodchips were absorbing water like a sponge would. Constant verification was needed to make sure that the moisture penetrated the soil deep enough to reach the gravel/sand/dirt layer. With the improved isolation trench and moisture content, the simulations started to give acceptable signals, but not for long. Added water in the cell transited to the lowest point corner of the cell, and a puddle formed in the isolation trench, breaking the isolation by bridging both sections (isolated bottom vs. slope covering material). Furthermore, leaks were present in the puddle area, thereby drawing even more electrical current.

It took three days to have sufficient water supply in order to do a full days work without being stopped waiting for the water reservoir to be refilled. The client preferred that the installer arrive only at the end of the project to reduce costs, so the defects in the lowest point area had to be temporarily repaired with duct-tape to reduce their signal noise.

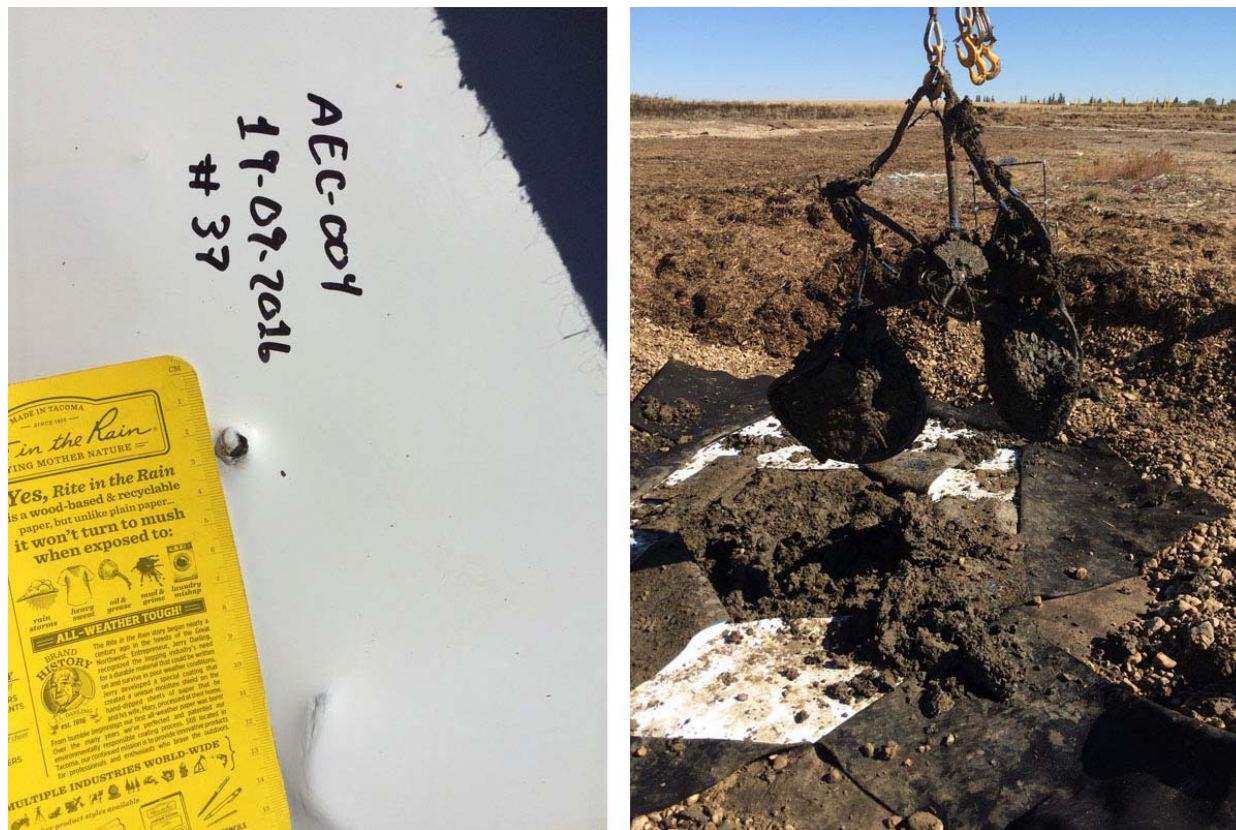
The strangest defect found was again a small piece of metal puncturing the liner. We tried to pull it off the ground with clamps to remove threat to the liner integrity right away, but could not. After enlarging the hole in the geomembrane and removing a little bit of clay on the side, we still had no success, even with

help. Finally the hole had to be opened on nearly a meter, and a mini-excavator pulled the metallic item with chains. It was an entire bicycle in the subgrade; the tip of the handlebar had pierced the geomembrane!

*Figure 6. Defect made from a bicycle in the subgrade*

After so many random metal scraps found in the subgrade, we asked the site owner and the general contractor if they had any clue as to why the subgrade was that poor quality. The reason they gave us is that the natural clay on site was not thick enough (one meter minimum per spec), so they had to bring in more clay and compact it after scraping off the topsoil. And, since the clay borrow area was so close to the cell, instead of putting clay in Haul truck to bring it to the work area, they simply pushed it with bulldozers. And their route was going over an active cell, so they collected lots of scraps and garbage in their clay.
