# Effectiveness of Quality Control on Geomembrane Installations, based on ELL Surveys

Carl Charpentier<sup>1</sup>, Arnaud Budka<sup>2</sup>, Thierry Jacquelin<sup>3</sup> & André Rollin<sup>4</sup>  
*Groupe Alphard, 4560B St-Laurent Blvd, Suite 202, Montreal (Qc), Canada H2T 1R3*

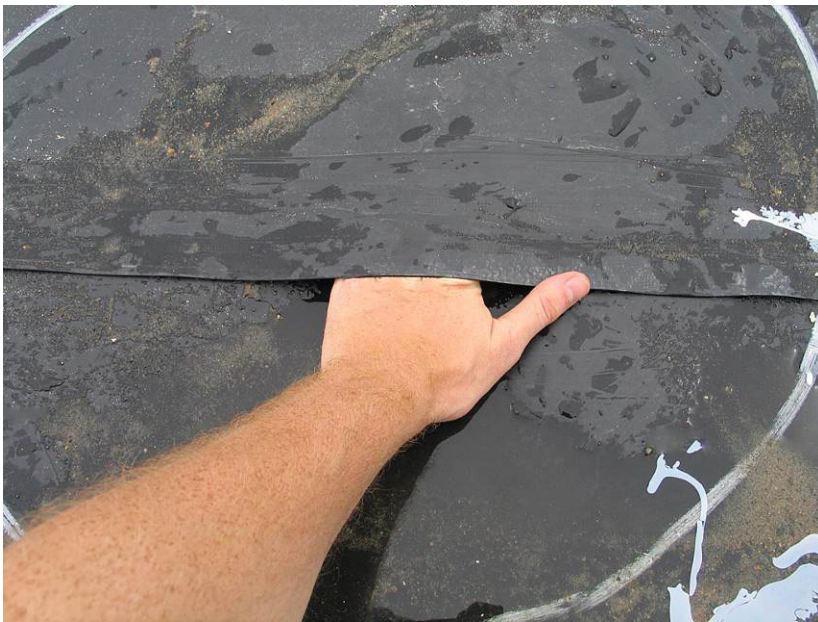
As illustrated by Figures 3 and 4, even with a successful air channel test, un-seamed areas and leaks along the edges of the seam can still be present. The origins of such defects can be various: for example, if the geomembrane overlap is too wide, it is forced into the welding machine, which compresses both geomembrane panels and creates a small ripple (Figure 5). As soon as the geomembrane exits the welding machine, it is no longer compressed. As the movement is very rapid and the liner very hot, the geomembrane can tear along the seams, which has been observed in Canada and in France on multiple projects. Other parameters should be considered, like ambient temperature changes, welding fusion temperature and welding machine speed.

Figure 3. Double fusion seam with an obstructed air channel and a large opening missed by the QC

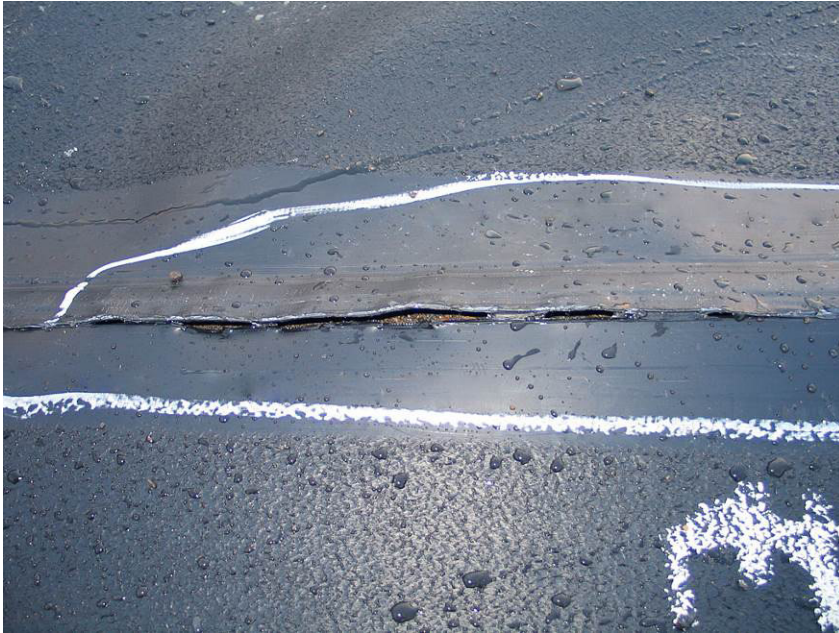
Figure 4. Overlap removed to show numerous holes along the edge of a positively tested air channel

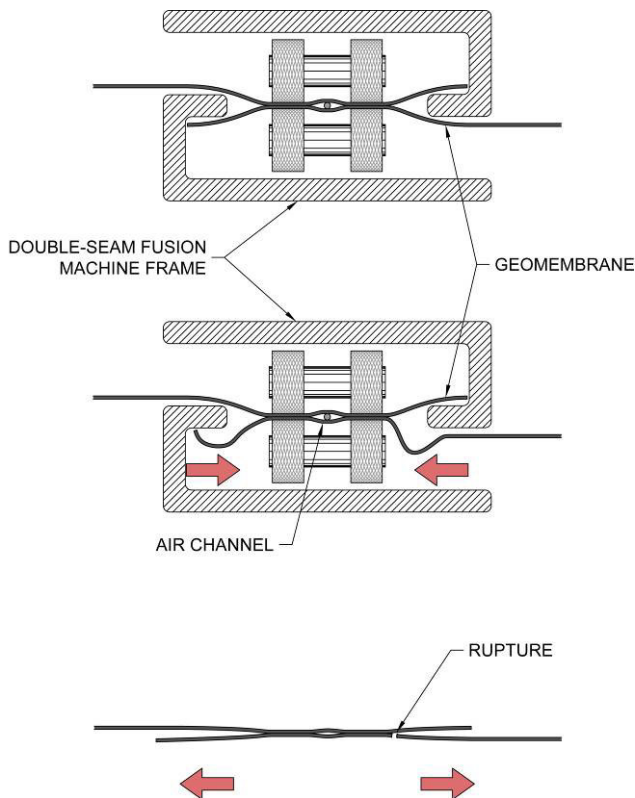
Figure 5. Scheme of a wide overlap squeezed in a double seam fusion machine

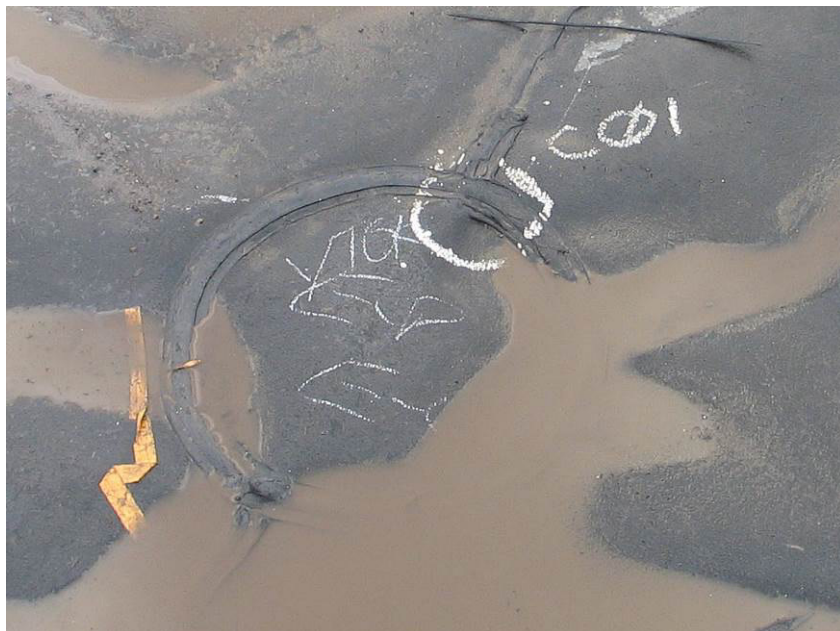
The vacuum box technique is widely used, as it is a simple, cheap and relatively reliable test that can occasionally locate defects. Based on past experience however, two major downsides have been identified: the first is that proper suction can only be achieved on an absolutely flat surface. It is very difficult to use this technique at the heel of a slope, or around accessories (pipes) that penetrate the liner without the use of pre-fabricated crossings made from pieces of pre-welded geomembrane. The other downside is that the vacuum box dirties very quickly, as it sucks in air from the sides, which mixes with water, soap and often dirt or sand. As such, the visibility through the box becomes rapidly compromised. Constant cleaning of inside of the vacuum box is mandatory.

Figure 6: VTOK stands for Vacuum Test OK, written 15 cm from a pin-sized hole

The vacuum box test cannot be considered as an absolute verification of a seam; it should be used in conjunction with an ELL survey. Whereas the vacuum box test can detect holes that were not detected during an ELL survey, likewise the ELL survey can detect holes that were not detected during the vacuum box test. It should be noted that the vacuum box test requires the full attention and dedication of the technician, as this method is based on visual observations. It is difficult to sustain the required concentration over an extended period of time; therefore this method should only be used on specific and limited areas such as repairs and extrusions.

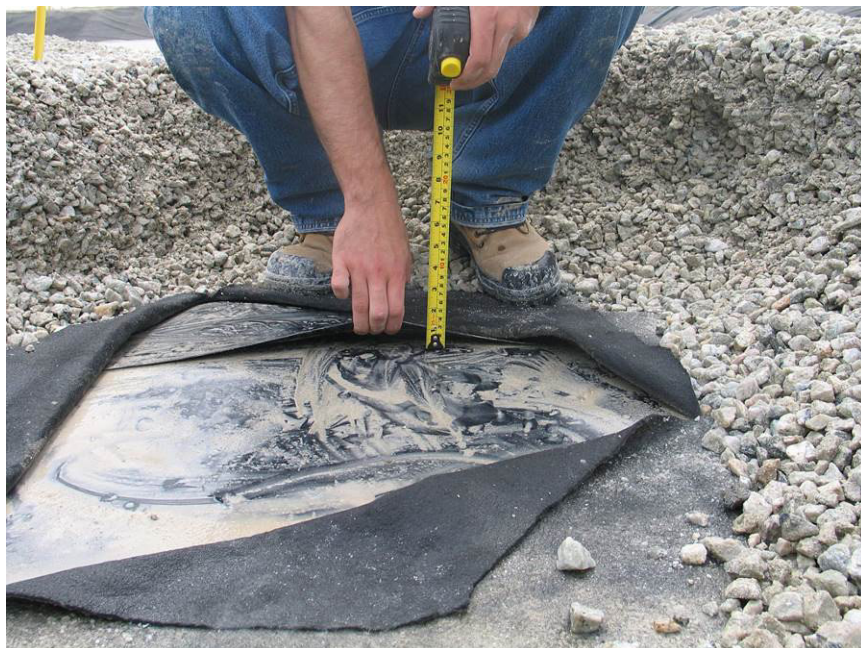
A final topic that is related to quality control, but is not an imperviousness test, is the calibration of the welding apparatus. Every installer should have specifications to achieve with regards to the seam strength (peel and shear). A calibration of the welding device is systematically needed to define the welding parameters (temperature, pressure and speed) required to reach the specifications. Non-destructive test methods are not sufficient to determine the seam's properties. For example, tension on the seam, due to the placement of the protective layer of natural materials, or the load applied by trucks circulating over the covered membrane, can cause the seam to peel apart. Figure 7 shows an example of this, which was detected using the dipole method.

Figure 7: Adhesion failure after placement of the protective layer
